PROPOSED REPLACEMENT OF SECTION OF FAILED DRAINAGE, TOWN MOOR, NARBERTH

PHOTOS

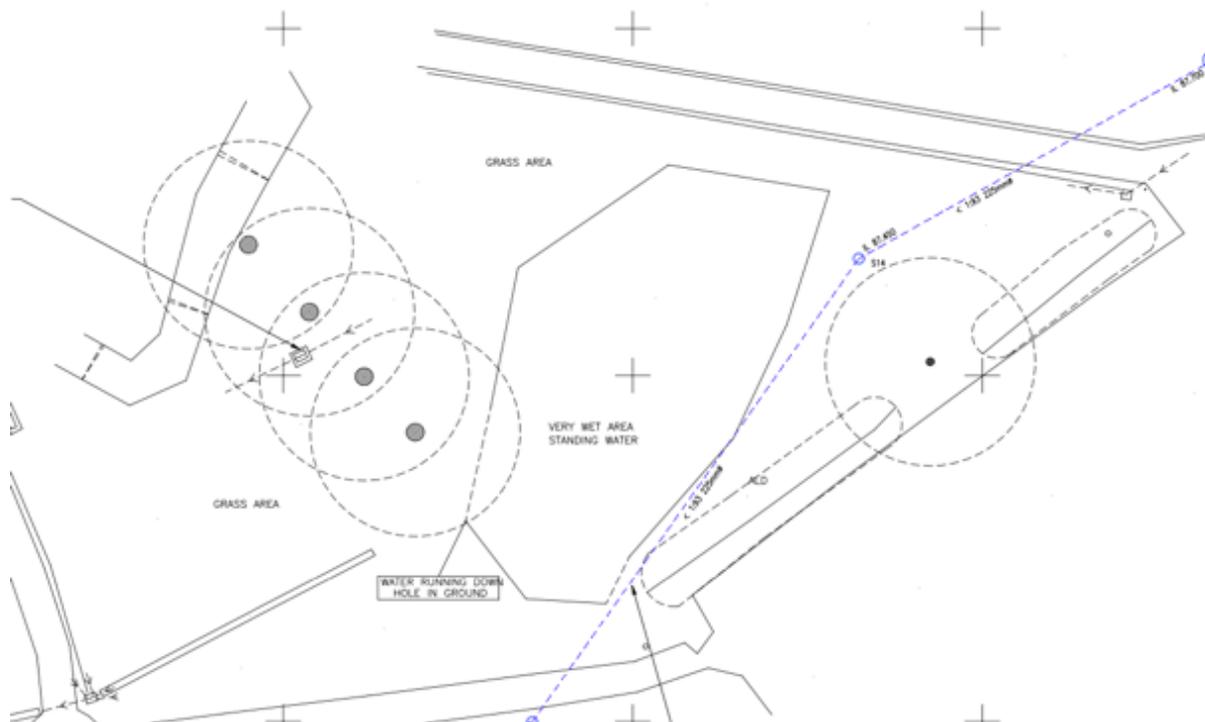
Excerpt from drawing 20447 – 05A is shown to help understand the following photographs. The area of wet and standing water shown is shown on the plan as well as the group of four trees through which the existing run passes to join up with the manhole by the intersection of the path. The land falls from north-east to south-west. The existing car park is in the space to the right of the single tree and hedge. The blue line is the proposed drainage route for the repair avoiding the group of trees and the single tree close to the car park boundary.

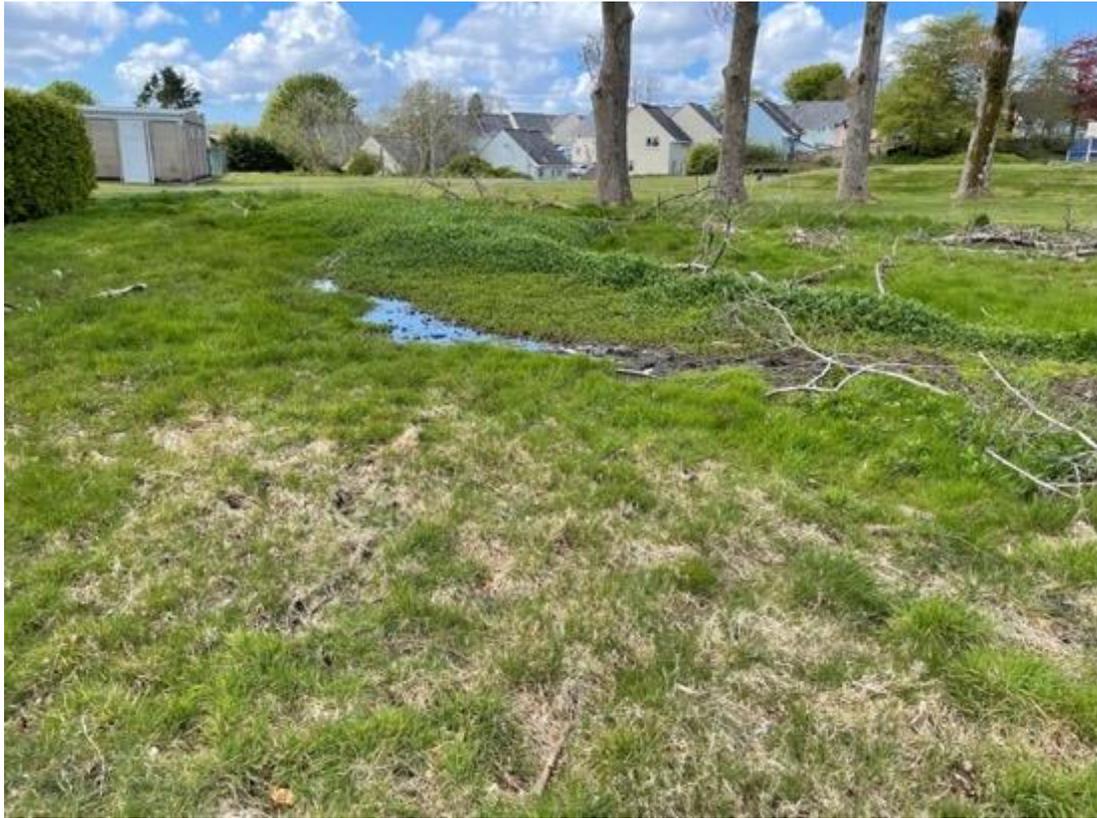
View looking south-west. Standing water on the site close to the group of trees.

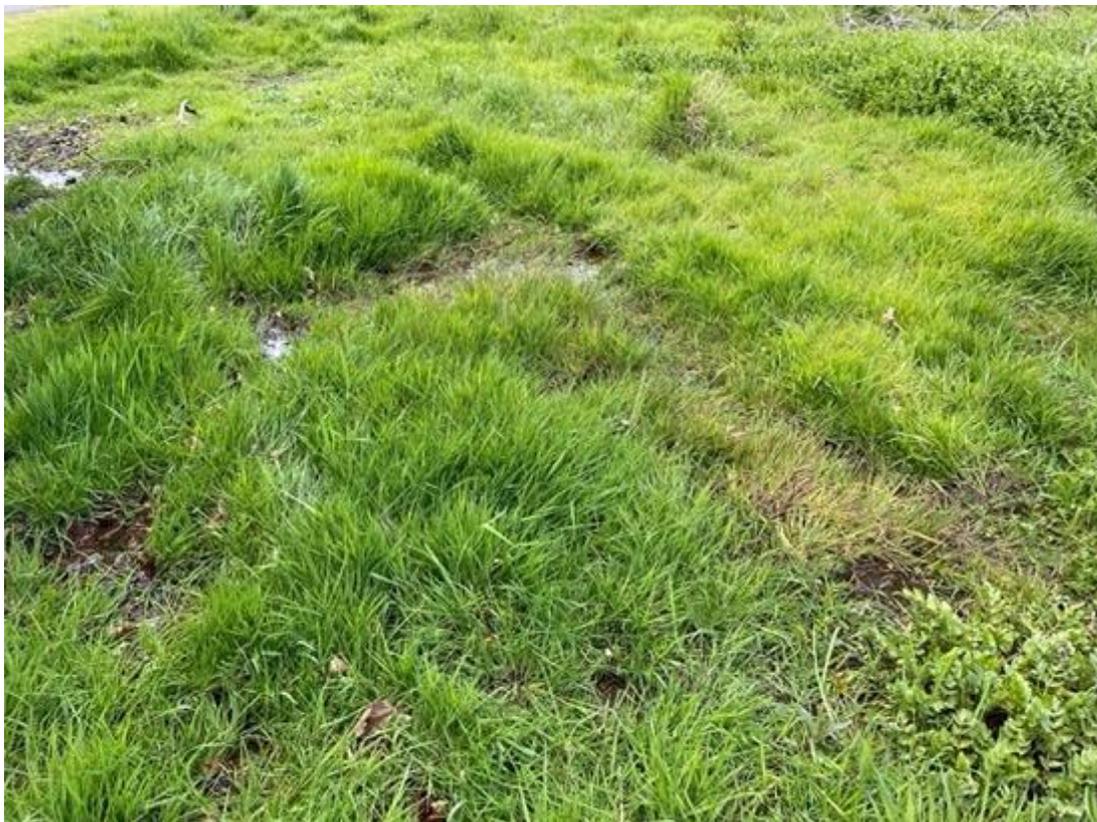
Standing water and very wet ground

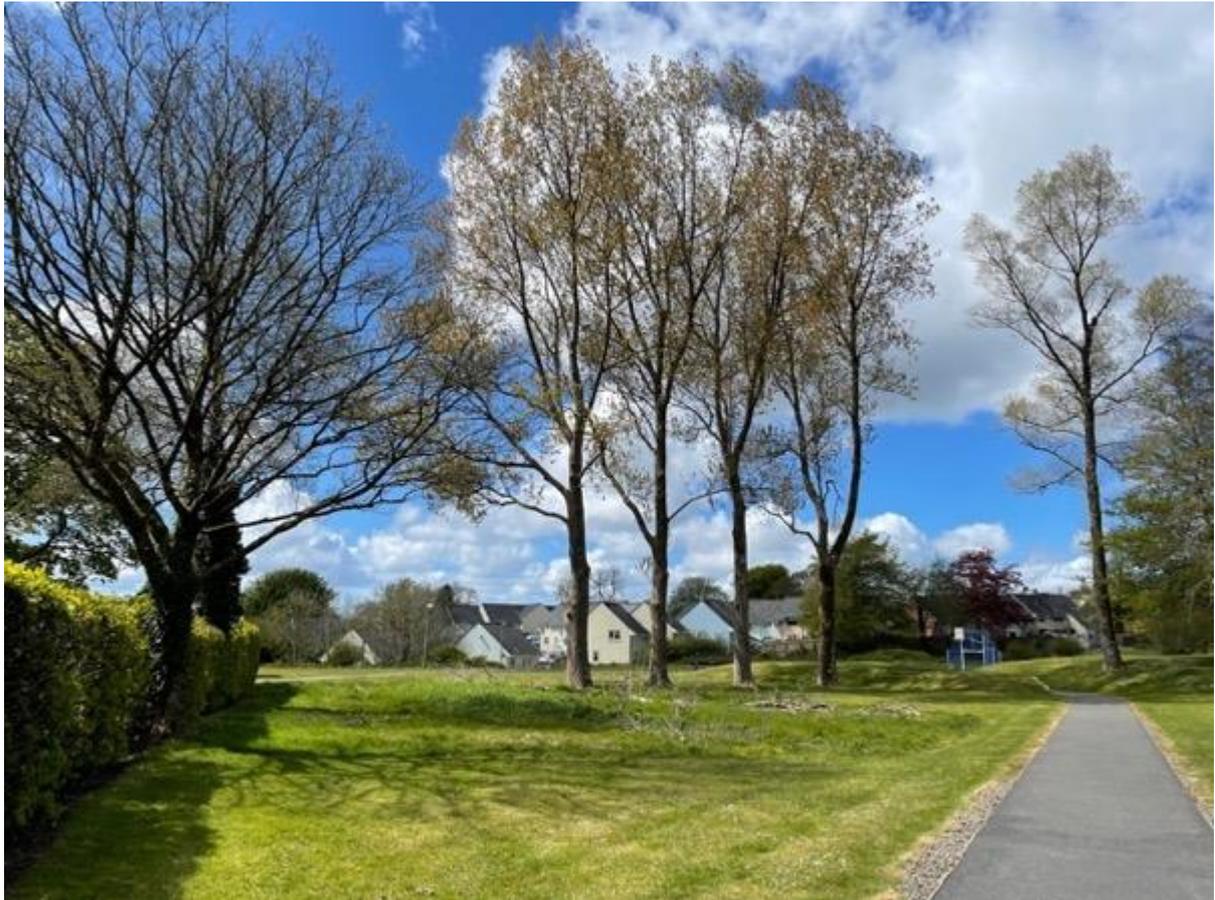
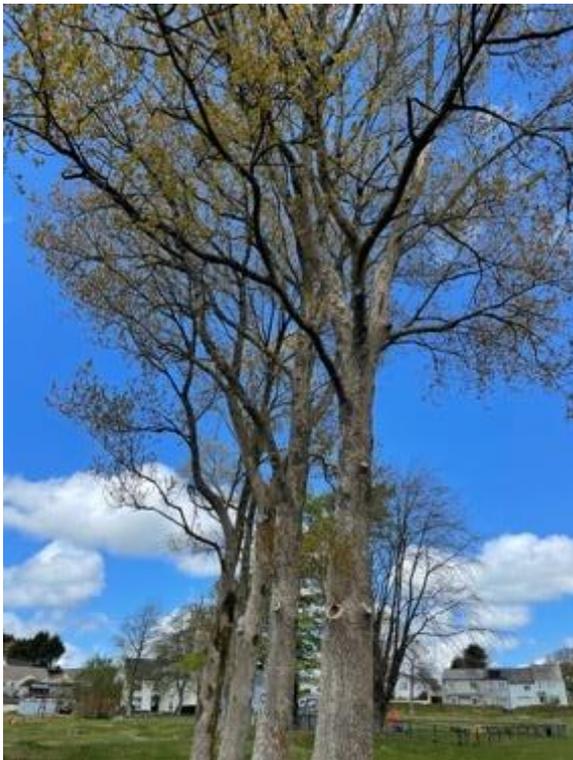
A view looking south-west across the Town Moor. The boundary to the car park is on your left.

The group of four trees with important landscape value in the Moor through which the current drainage passes can be seen on both these photographs.

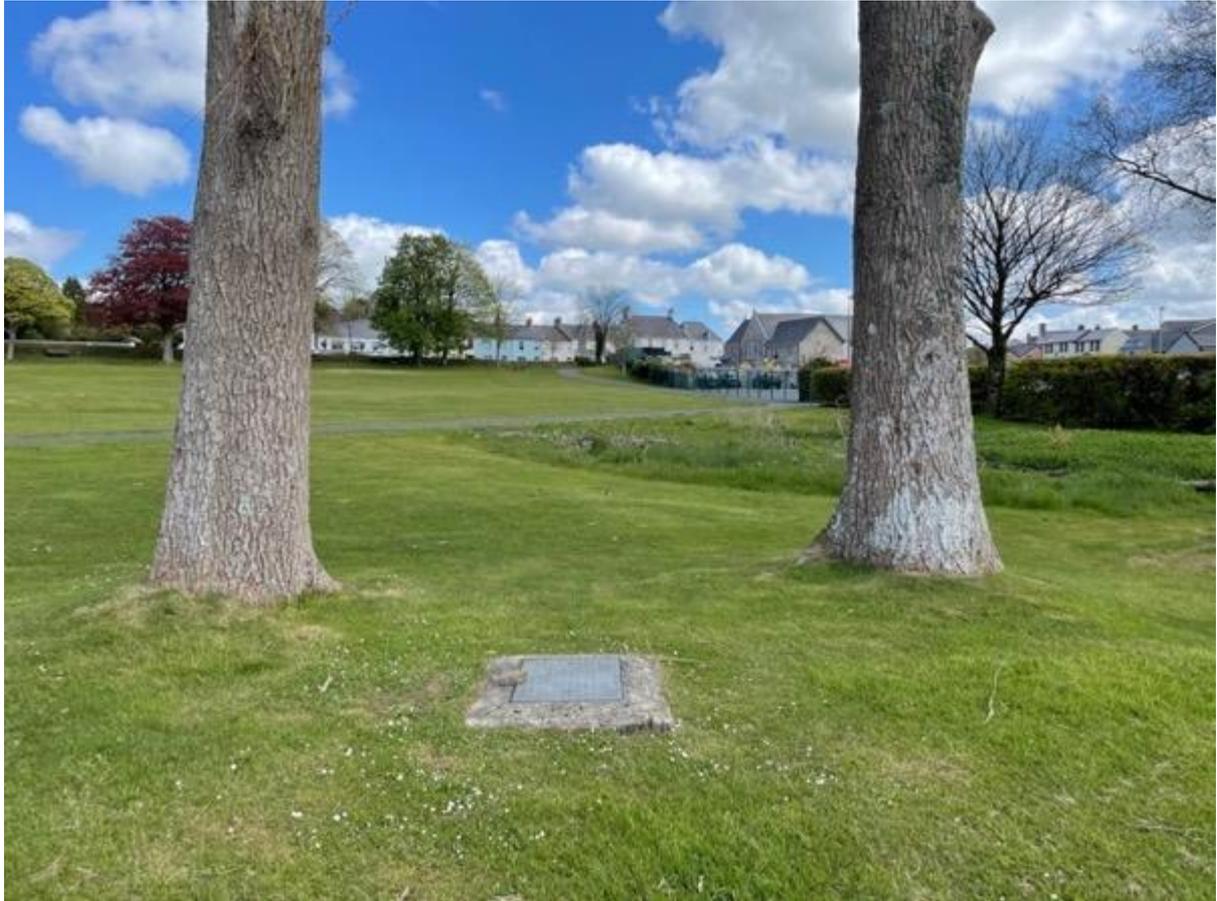
This is the location of the current drainage run which has failed. It passes through the centre of the group of four mature trees. Any repair of this existing run is likely to damage the trees.

The next manhole which is higher up the run is located close to where the hedge changes to fence. The area of wet ground can be seen (longer grass – harder to maintain).

The Narberth Old School Development can be seen just to the left of the right-hand tree.

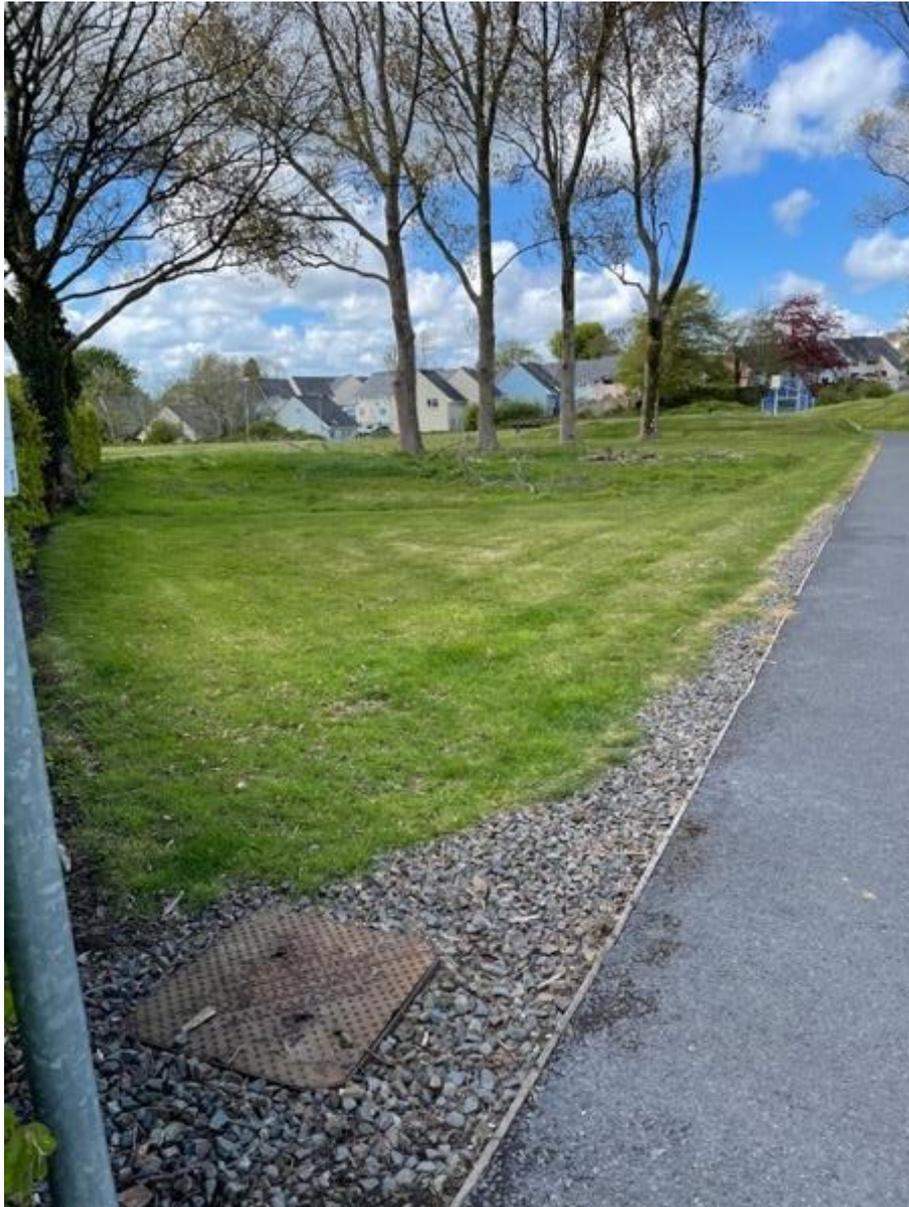
This is the opposite view looking from the upper manhole towards the ground of trees. The existing drainage which has failed runs through the centre of these trees. The proposed new route is between these group of trees and the single tree seen on the left of this photograph.
